## Technical Bulletin

# ***Corrosion Resistance of Heat Exchanger Fin Materials to Potassium Hydroxide Sodium Hypochlorite-Based Cleaning Chemicals and Ammonia***

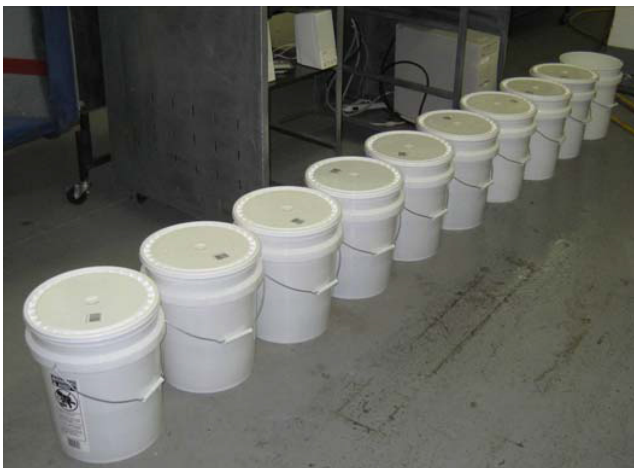
**Figure 1:** Testing containers containing test specimens and cleaning chemical

Each sample was tested in separate plastic containers with the fin sample placed collar down, suspending the fin in the solution the height of the fin collar above the bottom of the container. After the samples were placed in the cleaning solution, a tight

sealing lid was placed over the containers to prevent evaporation and contamination as described by NACE standard TM0169-2000 [1]. The ambient room temperature was maintained at approximately 70 degrees Fahrenheit and the samples were not moved. The solution was not aerated or circulated in the container in any way.

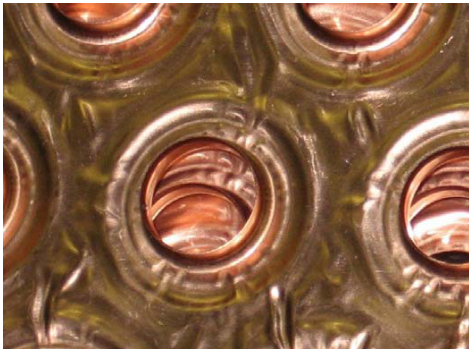
**Figure 2:** Copper C11000 sample before corrosion testing

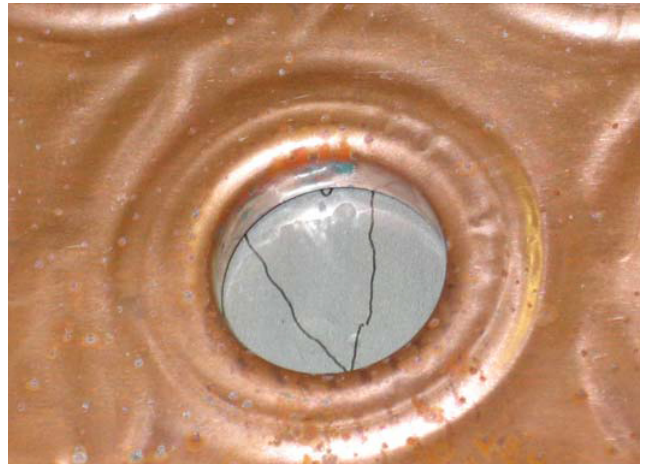
The test using Sunny-Sol 150 shown in Figures 3 and 4 shows some surface pitting, which appears very evenly distributed. The total amount of corrosion appears to be very minor and would not adversely affect coil performance. The test using FRM 63-CB shown in Figures 5 and 6 shows only minor corrosion. Small green patina formations were also evident on the surface of the fins after the samples were removed from the cleaning solution. These became more evident after the sample was cleaned and exposed to air for several days. The FRM 63-CB sample shows a much more dull finish indicating that the entire surface has been slightly etched, but it appears it would not affect coil performance.

**Figure 3:** Copper C11000 after 250 hours submerged in a .16% Sunny-Sol 150 water solution

**Figure 4:** Copper C11000 after 250 hours submerged in a .16% Sunny-Sol 150 water solution

| <b>Chlorinated Cleaner:<br/>sodium hypochlorite-based</b> | | |
|---|---|---|
| Copper C11000 | <b>Compatible</b> | Very minor pitting |

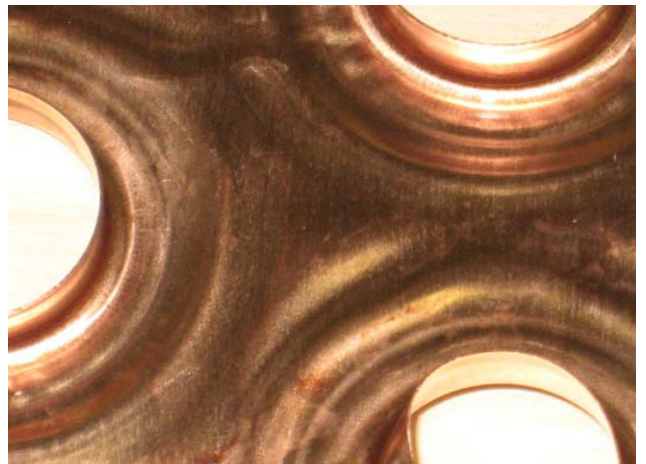
**Figure 5:** Copper C11000 after 250 hours submerged in a 3.9% FRM 63-CB water solution

**Figure 6:** Copper C11000 after 250 hours submerged in a 3.9% FRM 63-CB water solution

| Copper C11000 | <b>Compatible</b> | No visible corrosion |

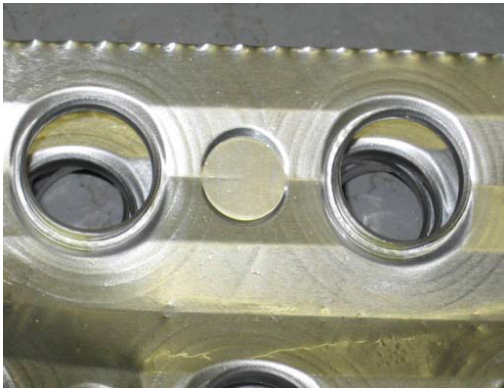
**Figure 7:** Aluminum 1100 sample before corrosion testing

The test using Sunny-Sol 150 shown in Figures 8 and 9 shows some surface corrosion, which appears in pockets distributed evenly over the entire surface. When the sample was removed from the cleaning solution, white precipitate had formed around the pockets of corrosion. The total amount of corrosion appears to be minor and is mostly the result of the aluminum oxide layer which forms on the surface and protects the underlying metal. The test using FRM 63-CB shown in Figure 10 shows almost complete corrosion of the fin material after only 250 hours. Figure 10 shows the result of the solution being strained through cheese cloth to recover the undissolved fin sample. As a result, we re-ran the test with the sample being removed at 60 hours and is shown in Figure 11. The sample showed significant corrosion and begins to totally break apart at 100 hours.

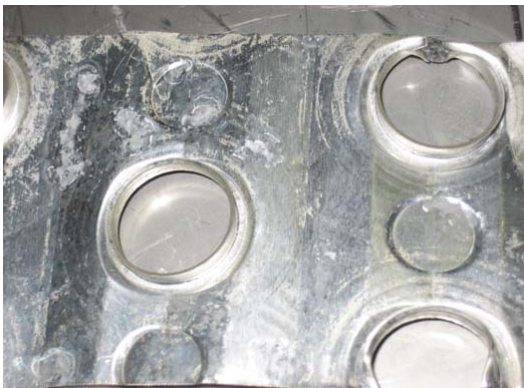
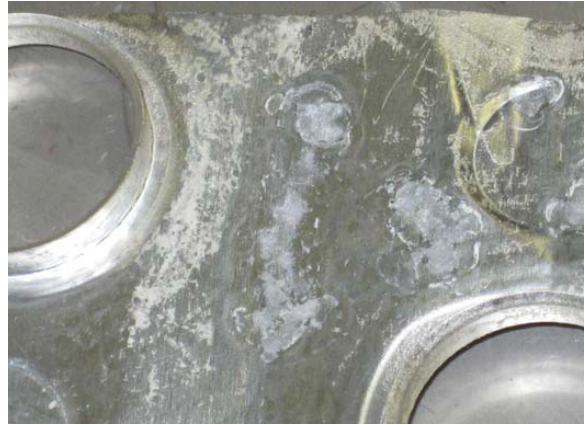
**Figure 8:** Aluminum 1100 after 250 hours submerged in a .16% Sunny-Sol 150 water solution

**Figure 9:** Aluminum 1100 after 250 hours submerged in a .16% Sunny-Sol 150 water solution

| <b>Chlorinated Cleaner:<br/>sodium hypochlorite-based</b> | | |
|---|---|---|
| Aluminum 1100 | <b>Compatible</b> | Surface oxidation |

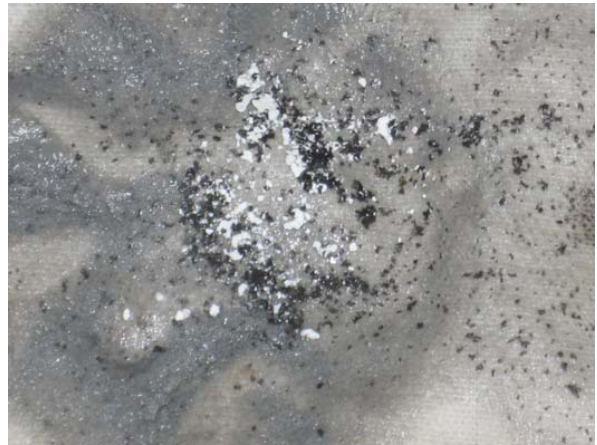
**Figure 10:** Aluminum 1100 after 250 hours submerged in a 3.9% FRM 63-CB water solution

**Figure 11:** Aluminum 1100 after 60 hours submerged in a 3.9% FRM 63-CB water solution

| Aluminum 1100 | <b>Incompatible</b> | Significant corrosion |

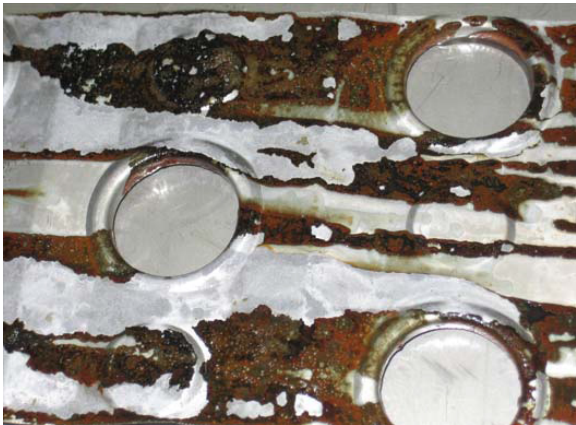
The test using Sunny-Sol 150 shown in Figures 13 and 14 shows significant corrosion with rust forming on large portions of the fin. The total amount of corrosion is significant and would adversely affect coil performance. The test using FRM 63-CB shown in Figures 15 and 16 shows virtually no corrosion. The FRM 63-CB sample shows a much more dull finish indicating that the entire surface has been slightly etched, and appears it would not affect coil performance. There is, however, one portion of the fin that showed significant corrosion which is most likely caused from contamination and the attack of a dissimilar metal.

Figure 13: Carbon steel after 250 hours submerged in a .16% Sunny-Sol 150 water solution

Figure 14: Carbon steel after 250 hours submerged in a .16% Sunny-Sol 150 water solution

| <b>Chlorinated Cleaner:<br/>sodium hypochlorite-based</b> | | |
|---|---|---|
| Carbon Steel | <b>Incompatible</b> | Significant corrosion |

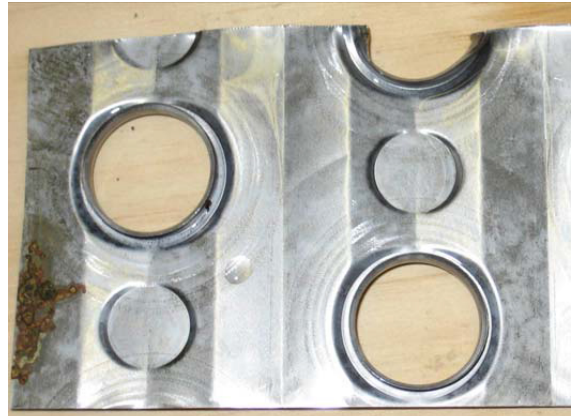
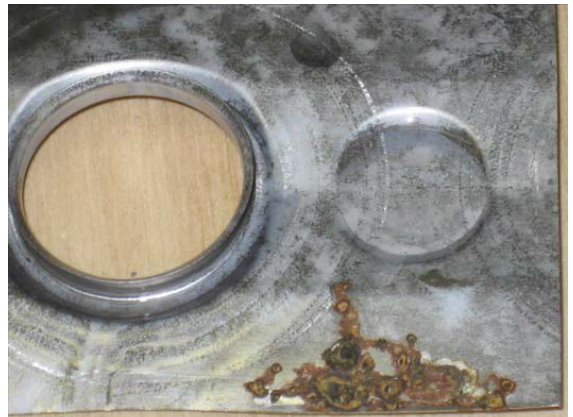
Figure 15: Carbon steel after 250 hours submerged in a 3.9% FRM 63-CB water solution

Figure 16: Carbon steel after 250 hours submerged in a 3.9% FRM 63-CB water solution

| Carbon Steel | <b>Compatible</b> | Minor surface oxidation |

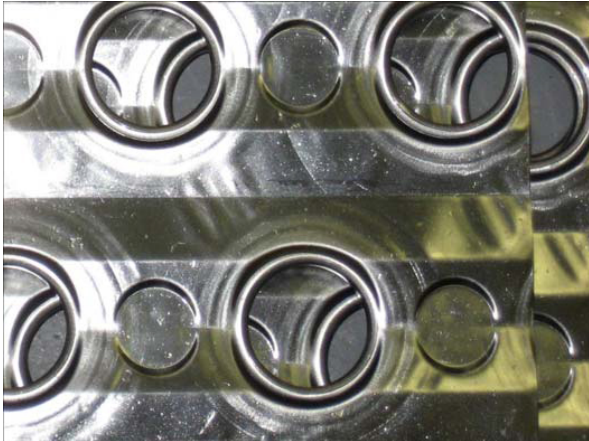
**Figure 17:** 316 Stainless steel sample before corrosion testing

The test using Sunny-Sol 150 shown in Figures 18 and 19 shows no corrosion; the cleaner acts only to clean the metal surface more thoroughly than acetone. The test using FRM 63-CB shown in Figures 20 and 21 also shows no corrosion, but possibly a slight tarnishing.

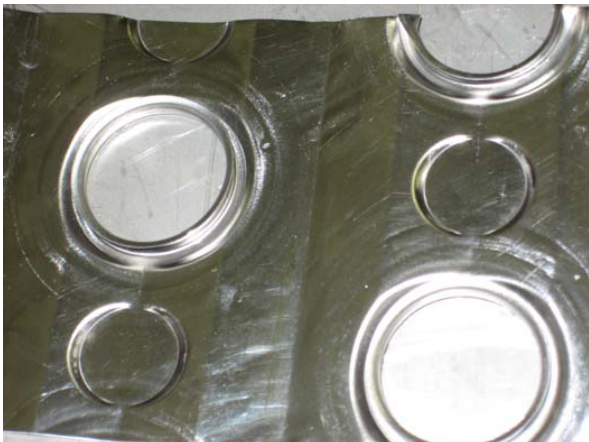
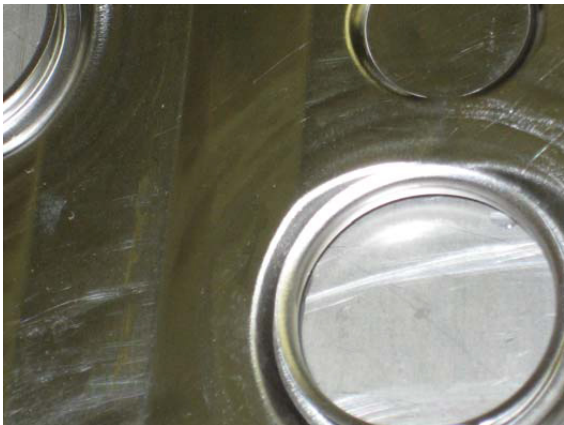
**Figure 18:** 316 Stainless steel after 250 hours submerged in a .16% Sunny-Sol 150 water solution

**Figure 19:** 316 Stainless steel after 250 hours submerged in a .16% Sunny-Sol 150 water solution

| <b>Chlorinated Cleaner:<br/>sodium hypochlorite-based</b> | | |
|---|---|---|
| Stainless steel 316 | <b>Compatible</b> | No visible corrosion |

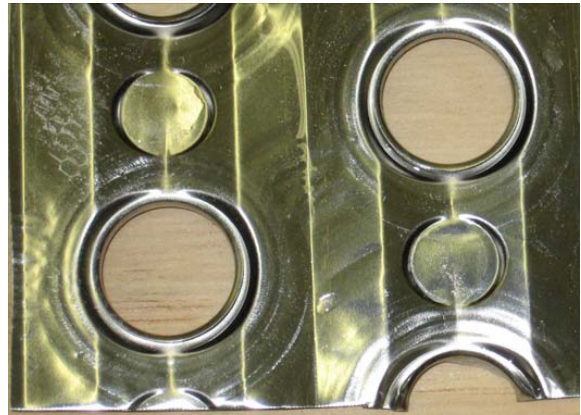
**Figure 20:** 316 Stainless steel after 250 hours submerged in a 3.9% FRM 63-CB water solution

**Figure 21:** 316 Stainless steel after 250 hours submerged in a 3.9% FRM 63-CB water solution

| Stainless steel 316 | <b>Compatible</b> | No visible corrosion |

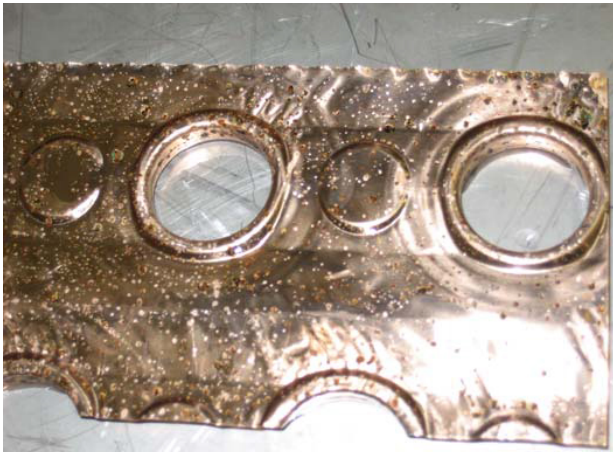
The test using Sunny-Sol 150 shown in Figures 23 and 24 shows minor pitting that is similar to the copper C11000 sample. The test using FRM 63-CB shown in Figures 25 and 26 shows no corrosion and cleans the surface very effectively.

Figure 23: 95/5 Copper-nickel after 250 hours submerged in a .16% Sunny-Sol 150 water solution

Figure 24: 95/5 Copper-nickel after 250 hours submerged in a .16% Sunny-Sol 150 water solution

| <b>Chlorinated Cleaner:<br/>sodium hypochlorite-based</b> | | |
|---|---|---|
| Copper-Nickel 95/5 | <b>Incompatible</b> | Surface pitting |

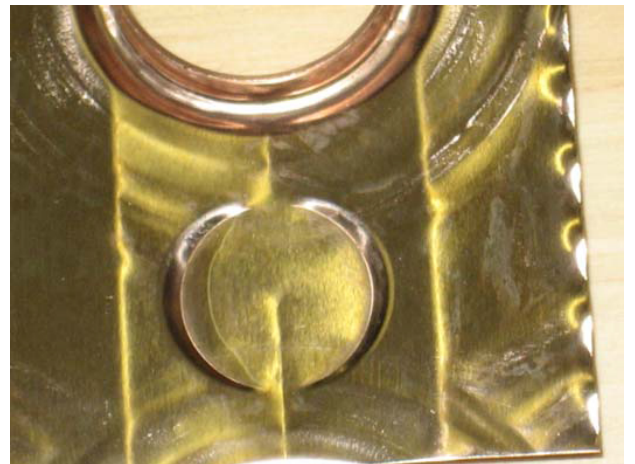
Figure 25: 95/5 Copper-nickel after 250 hours submerged in a 3.9% FRM 63-CB water solution

Figure 26: 95/5 Copper-nickel after 250 hours submerged in a 3.9% FRM 63-CB water solution

| Copper-Nickel 95/5 | <b>Compatible</b> | No visible corrosion |

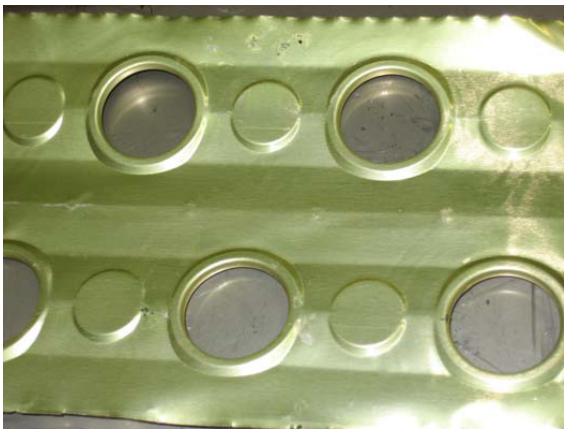
The test using Sunny-Sol 150 shown in Figures 28 and 29 shows only minor pitting in locations where the coating has been removed. The test using FRM 63-CB shown in Figures 30 and 31 shows corrosion being initiated at end exposed edges and where cuts form in the polycoat from the fin press dies. The aluminum is essentially removed from in between the two polycoat layers on the top and bottom, and very little aluminum remained after 250 hours.

**Figure 28:** Aluminum polycoat after 250 hours submerged in a .16% Sunny-Sol 150 water solution

**Figure 29:** Aluminum polycoat after 250 hours submerged in a .16% Sunny-Sol 150 water solution

| <b>Chlorinated Cleaner:<br/>sodium hypochlorite-based</b> | | |
|---|---|---|
| Aluminum 1100 w/<br>polycoat finish | <b>Compatible</b> | No visible corrosion |

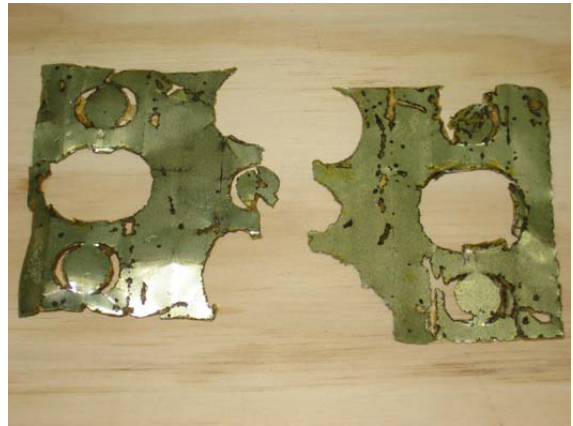
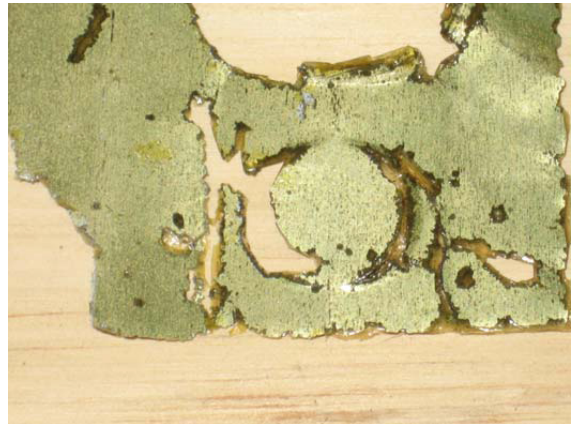
**Figure 30:** Aluminum polycoat after 250 hours submerged in a 3.9% FRM 63-CB water solution

**Figure 31:** Aluminum polycoat after 250 hours submerged in a 3.9% FRM 63-CB water solution

| Aluminum 1100 w/<br>polycoat finish | <b>Incompatible</b> | Chemical dissolves aluminum portion at cracks, creases and edges |

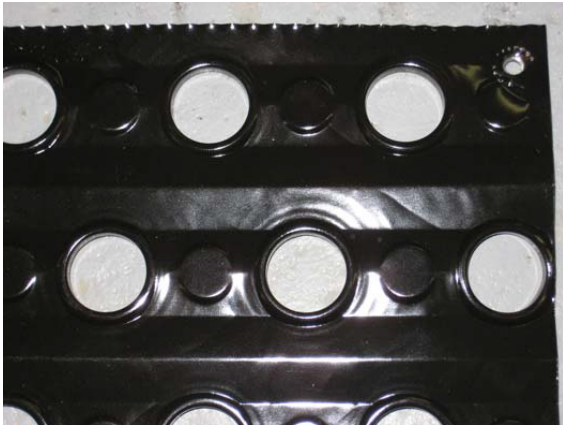
**Figure 32:** Aluminum Electrofin sample before corrosion testing

The test using Sunny-Sol 150 shown in Figures 33 and 34 shows only minor corrosion at locations where the coating has been removed. The test using FRM 63-CB shown in Figures 35 and 36 shows corrosion being initiated at the exposed edges. FRM 63-CB also causes the coating to become brittle and flake off the sample.

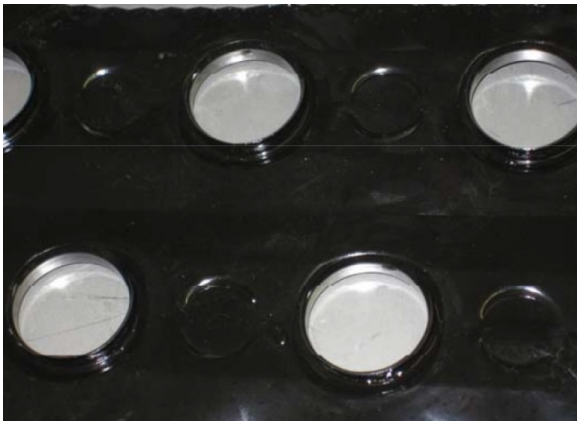
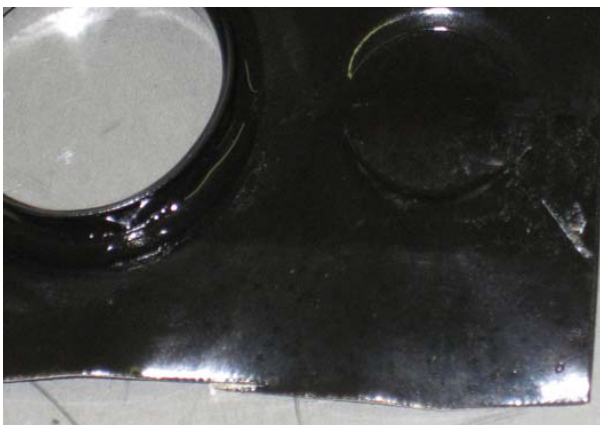
**Figure 33:** Aluminum Electrofin after 250 hours submerged in a .16% Sunny-Sol 150 water solution

**Figure 34:** Aluminum Electrofin after 250 hours submerged in a .16% Sunny-Sol 150 water solution

| <b>Chlorinated Cleaner:<br/>sodium hypochlorite-based</b> | | |
|---|---|---|
| Aluminum 1100 w/<br>Electrofin coating | <b>Compatible</b> | No visible corrosion |

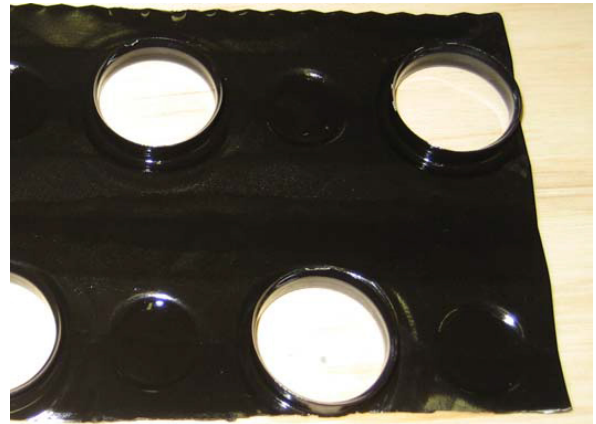
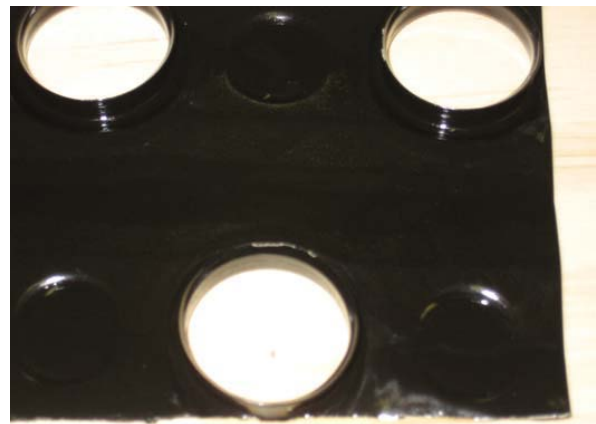
**Figure 35:** Aluminum Electrofin after 250 hours submerged in a 3.9% FRM 63-CB water solution

**Figure 36:** Aluminum Electrofin after 250 hours submerged in a 3.9% FRM 63-CB water solution

| Aluminum 1100 w/<br>Electrofin coating | <b>Incompatible</b> | Chemical causes cracks to develop in the surface coating allowing material to easily flake off exposing base aluminum |

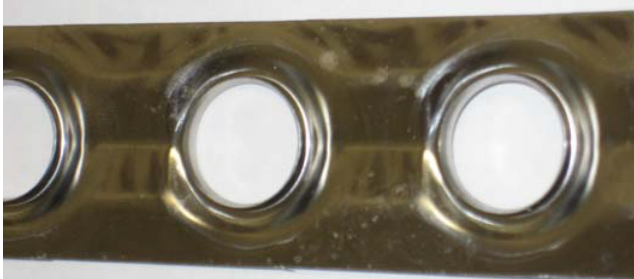
**Figure 37:** 304 Stainless steel sample before corrosion testing

The test using Sunny-Sol 150 shown in Figures 38 and 39 shows no corrosion; the cleaner acts only to clean the metal surface more thoroughly than acetone. The test using FRM 63-CB shown in Figures 40 and 41 shows minimal corrosion with some surface tarnishing in addition to the formation of a white scale. This scale is not easily removed by light scrubbing, but can be removed by scraping the surface leaving no visible corrosion beneath. Both cleaners appear to be acceptable for use on 304 stainless steel.

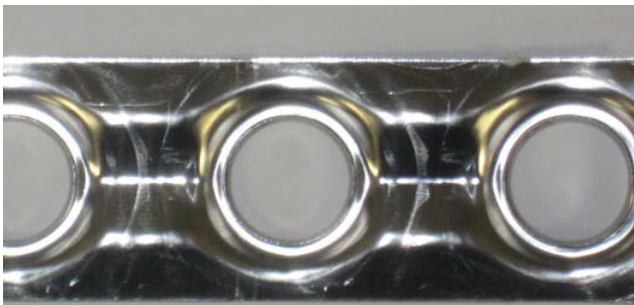
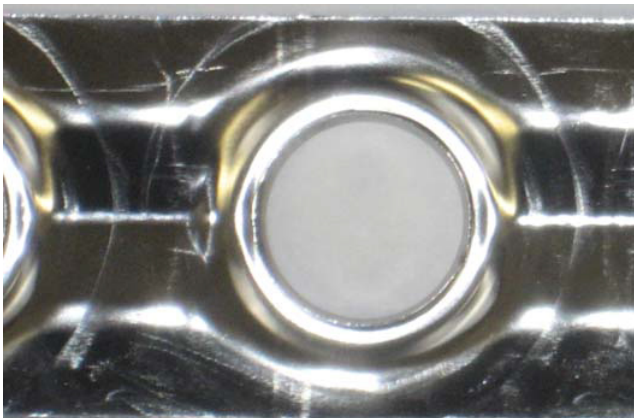
**Figure 38:** 304 Stainless steel after 250 hours submerged in a .16% Sunny-Sol 150 water solution

**Figure 39:** 304 Stainless steel after 250 hours submerged in a .16% Sunny-Sol 150 water solution

| <b>Chlorinated Cleaner:<br/>sodium hypochlorite-based</b> | | |
|---|---|---|
| Stainless steel 304 | <b>Compatible</b> | Very minor corrosion similar to stainless steel 316 |

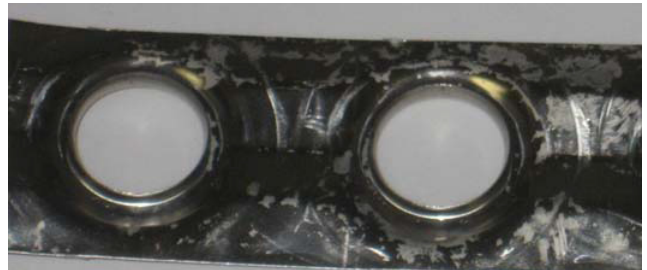
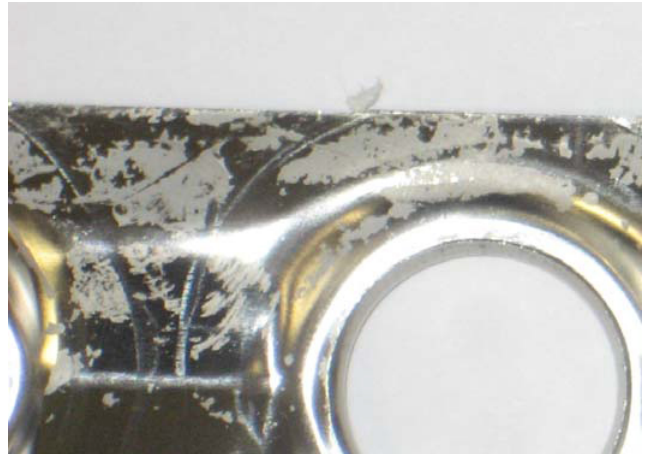
**Figure 40:** 304 Stainless steel after 250 hours submerged in a 3.9% FRM 63-CB water solution

**Figure 41:** 304 Stainless steel after 250 hours submerged in a 3.9% FRM 63-CB water solution

| Stainless steel 304 | <b>Compatible</b> | Minor corrosion |

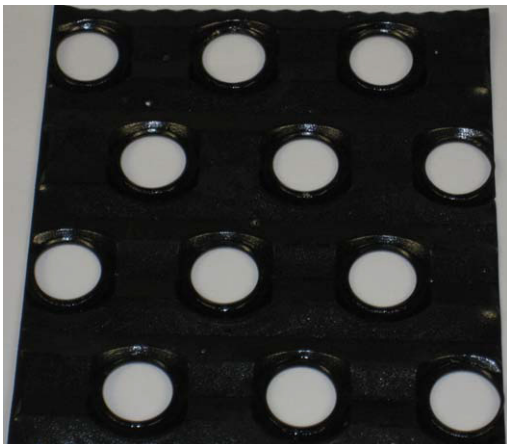
The test using Sunny-Sol 150 shown in Figures 43 and 44 shows no corrosion and appears to be compatible with sodium hypochlorite-based cleaners. The test sample using the FRM 63-CB cleaner shown in Figures 45 and 46 looks unaffected at first, but upon closer inspection, certain locations mostly at the fin collar edge and base, showed significant deterioration. This would have a substantial adverse effect on the tube-fin bond, significantly reducing heat transfer, and making a caustic-type cleaner not recommended for Heresite coils.

**Figure 44:** Black Heresite after 250 hours submerged in a .16% Sunny-Sol 150 water solution

**Figure 43:** Black Heresite after 250 hours submerged in a .16% Sunny-Sol 150 water solution

| <b>Chlorinated Cleaner:<br/>sodium hypochlorite-based</b> | | |
|---|---|---|
| Black Heresite | <b>Compatible</b> | Very minor pitting corrosion—not enough to adversely affect fin performance |

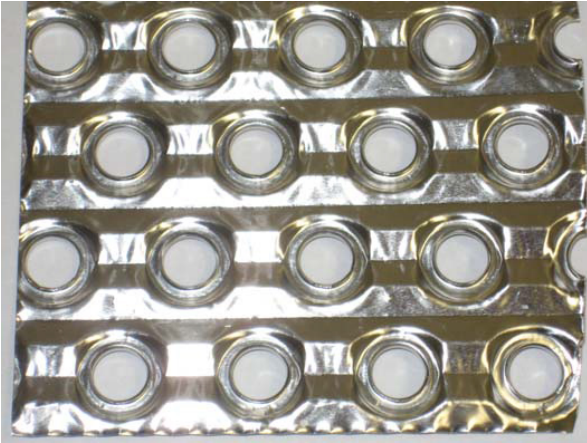
Figure 47: 5052 Aluminum sample before corrosion testing

The test using Sunny-Sol 150 shown in Figures 48 and 49 shows severe corrosion in several locations while the majority of the fin appears relatively unaffected. Where corrosion is present, the chemical cleaner has completely removed small portions of the fin. The test using FRM 63-CB shown in Figure 50 shows the sample being completely dissolved; only very small specs of the fin sample remain after 250 hours.

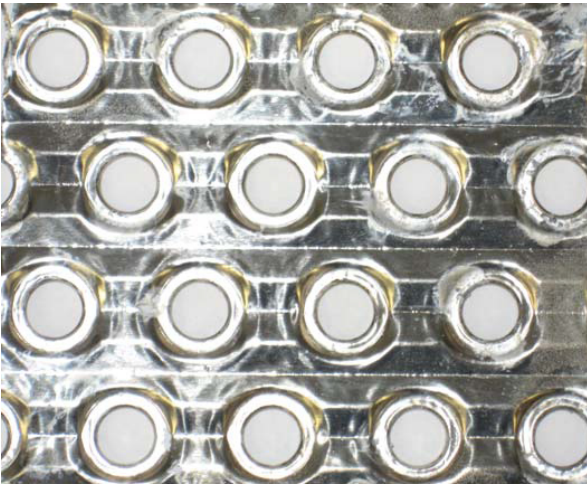
Figure 48: 5052 Aluminum after 250 hours submerged in a .16% Sunny-Sol 150 water solution

Figure 49: 5052 Aluminum after 250 hours submerged in a .16% Sunny-Sol 150 water solution

| <b>Chlorinated Cleaner:<br/>sodium hypochlorite-based</b> | | |
|---|---|---|
| Aluminum 5052 | <b>Incompatible</b> | Corrosion in several locations |

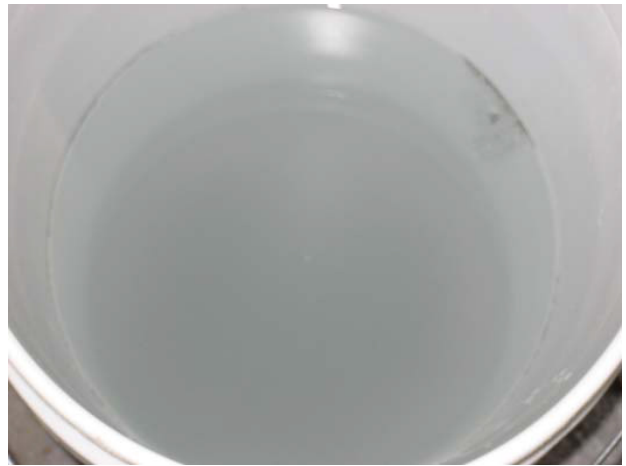
Figure 50: 5052 Aluminum after 250 hours submerged in a 3.9% FRM 63-CB water solution

| Aluminum 5052 | <b>Incompatible</b> | Completely dissolved material before test was complete |

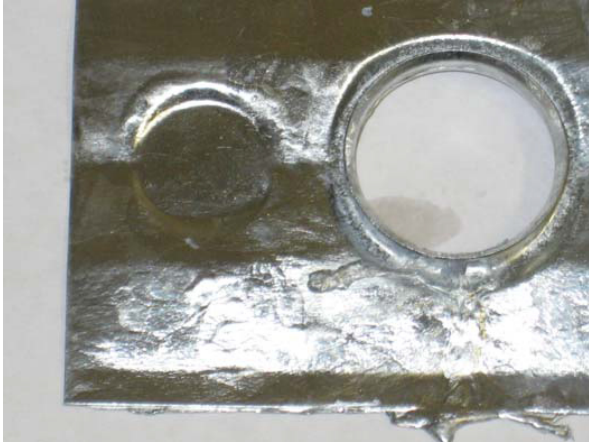
**Figure 51:** Hot dipped galvanized steel sample before corrosion testing

The test using Sunny-Sol 150 shown in Figures 52 and 53 shows surface corrosion of the galvanized coating, but does not appear to have reached the underlying carbon steel. The test using FRM 63-CB shown in Figures 54 and 55 shows much less corrosion and isolated pockets of a black tarnish forming on top of the galvanized coating.

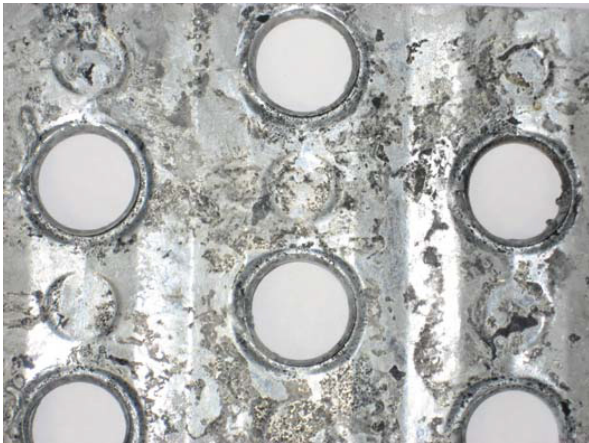
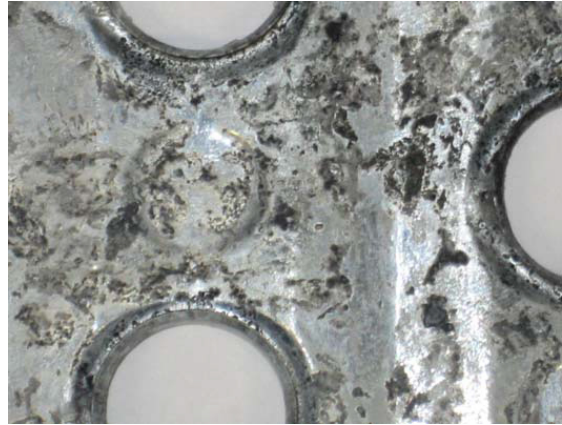
**Figure 52:** Hot dipped galvanized steel after 250 hours submerged in a .16% Sunny-Sol 150 water solution

**Figure 53:** Hot dipped galvanized steel after 250 hours submerged in a .16% Sunny-Sol 150 water solution

| <b>Chlorinated Cleaner:<br/>sodium hypochlorite-based</b> | | |
|---|---|---|
| Hot dipped galvanized steel | <b>Compatible</b> | Surface oxidation |

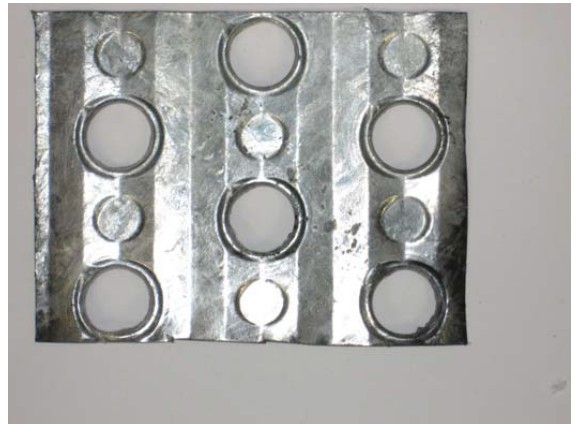
**Figure 54:** Hot dipped galvanized steel after 250 hours submerged in a 3.9% FRM 63-CB water solution

**Figure 55:** Hot dipped galvanized steel after 250 hours submerged in a 3.9% FRM 63-CB water solution

| Hot dipped galvanized steel | <b>Compatible</b> | Minor surface oxidation |

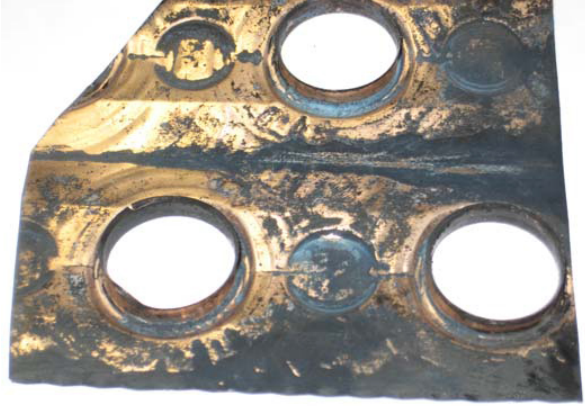
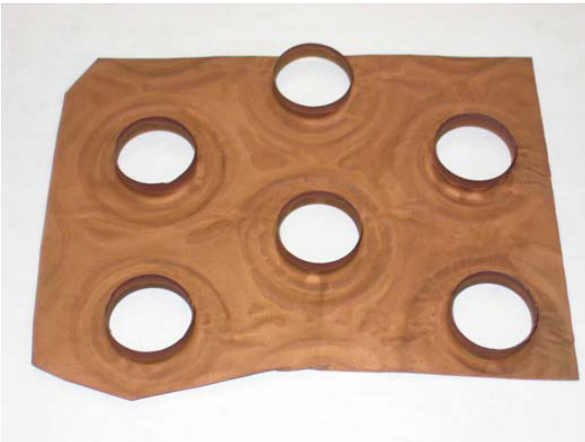
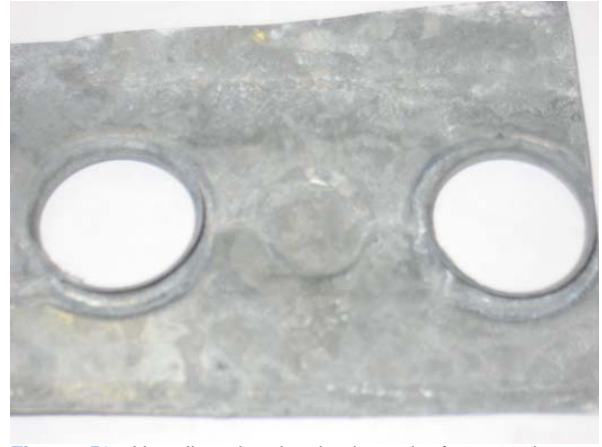
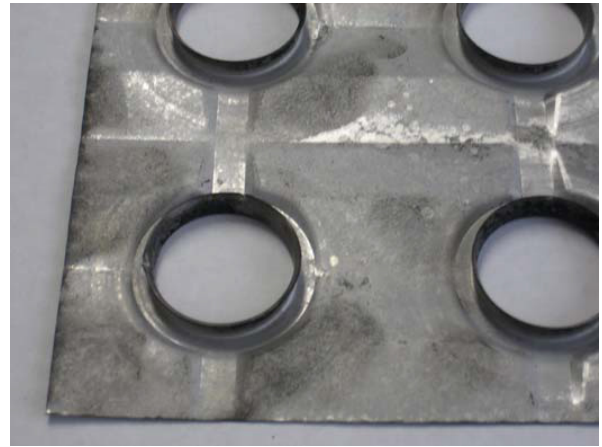
The tests using ammonium hydroxide all show some kind of surface oxidation on the fin stock, but no significant corrosion or fin deterioration. Future tests involving higher concentrations of ammonium hydroxide or pure ammonia may need to be completed also.

**Figure 56:** Copper-nickel 95/5 after 500 hours submerged in a 10% ammonium hydroxide solution

**Figure 57:** Copper C11000 after 500 hours submerged in a 10% ammonium hydroxide solution

**Figure 58:** Hot dipped galvanized steel after 500 hours submerged in a 10% ammonium hydroxide solution

**Figure 59:** 1100 series aluminum after 500 hours submerged in a 10% ammonium hydroxide solution

The tests using ammonium hydroxide all show some kind of surface oxidation on the fin stock, but no significant corrosion or fin deterioration. Future tests involving higher concentrations of ammonium hydroxide or pure ammonia may need to be completed also.
